**National
Transportation
Safety Board**

**Motorcoach Run Off Road – Collision
With Vertical Highway Signpost
Interstate Highway 95 Southbound
New York City, New York
March 12, 2011, 5:38 a.m. EST**

Opening Statement

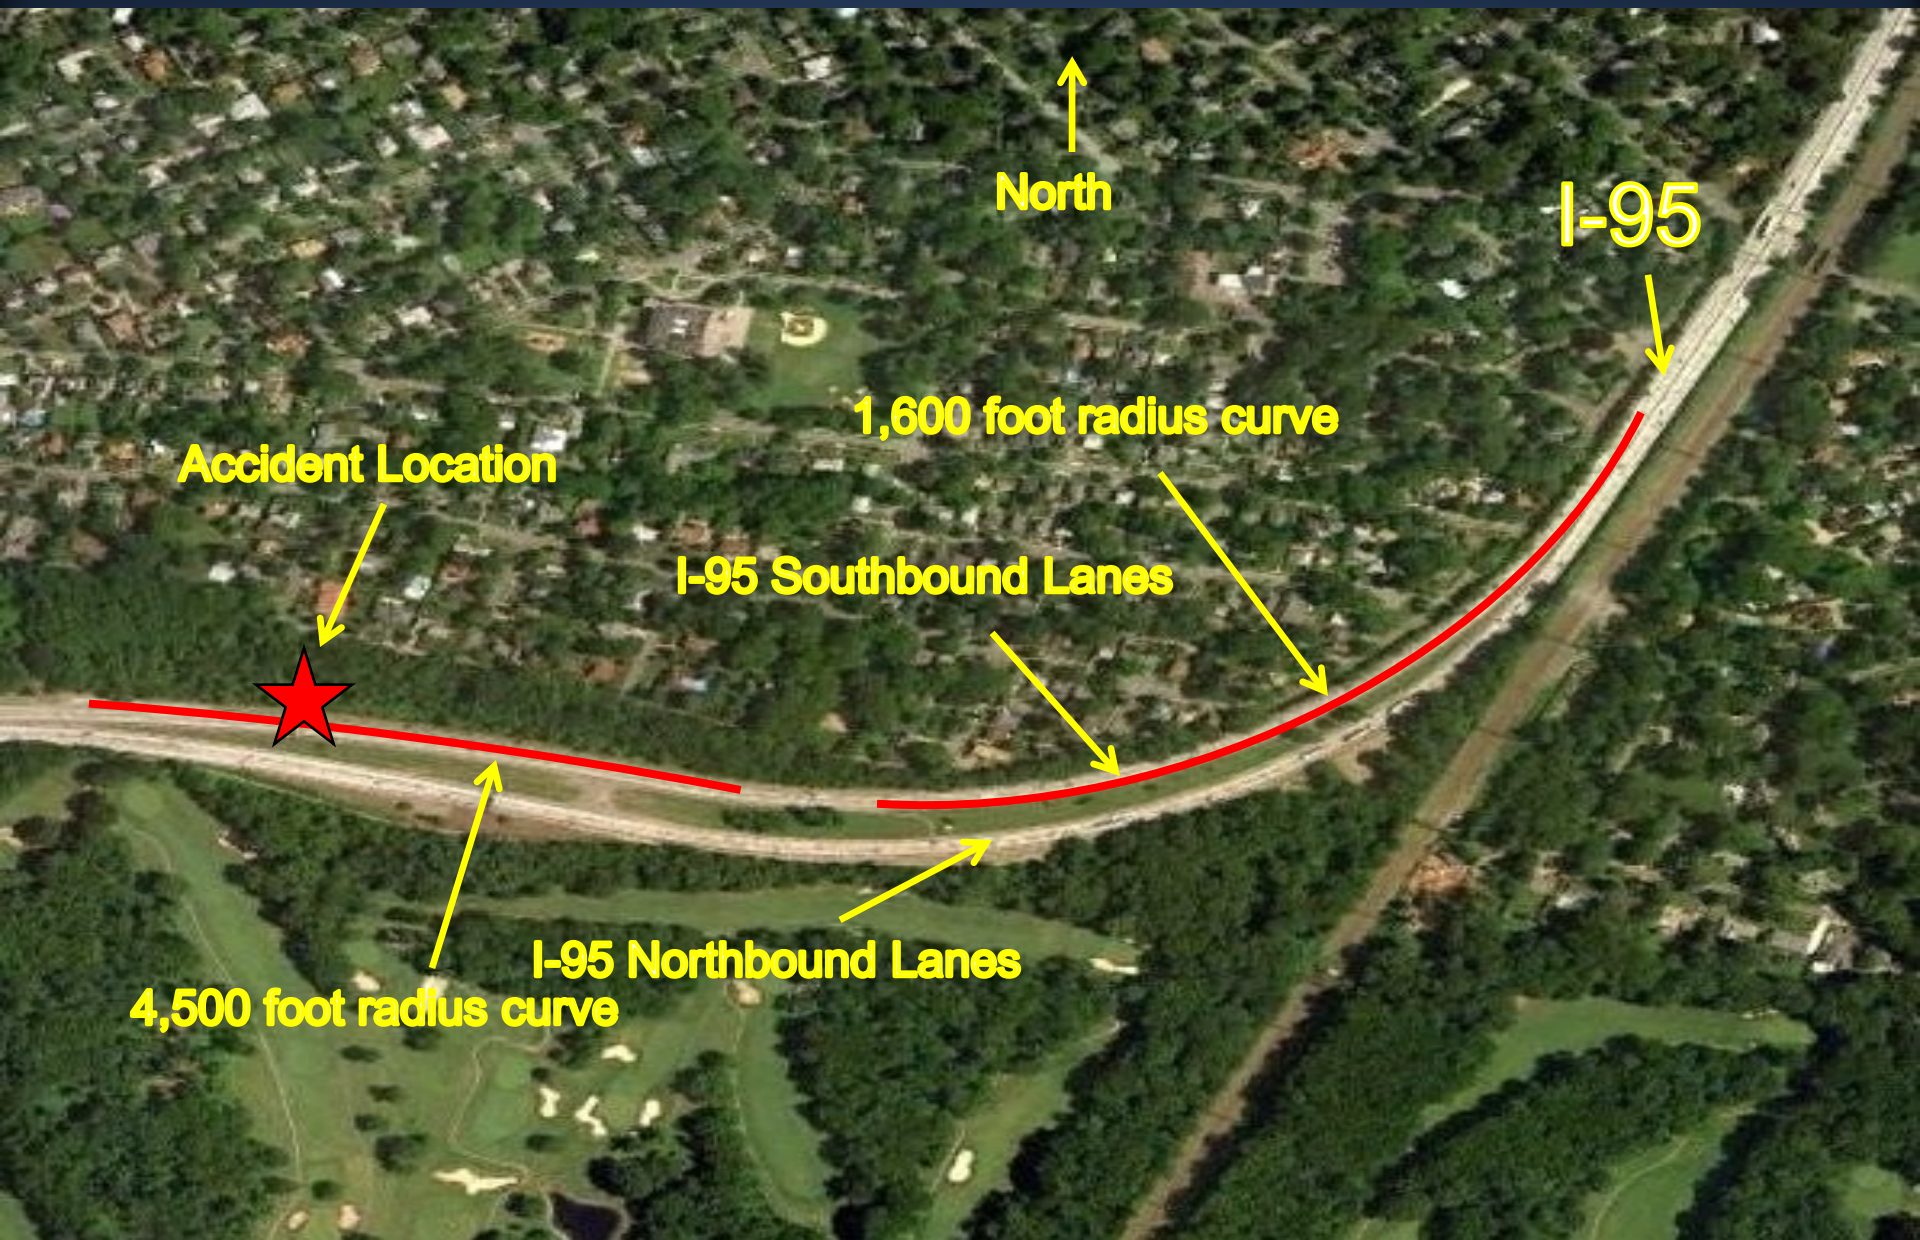
Aerial View - Accident Location

Impacts vertical
highway signpost

Impacts guardrail

Crosses shoulder

Departs roadway

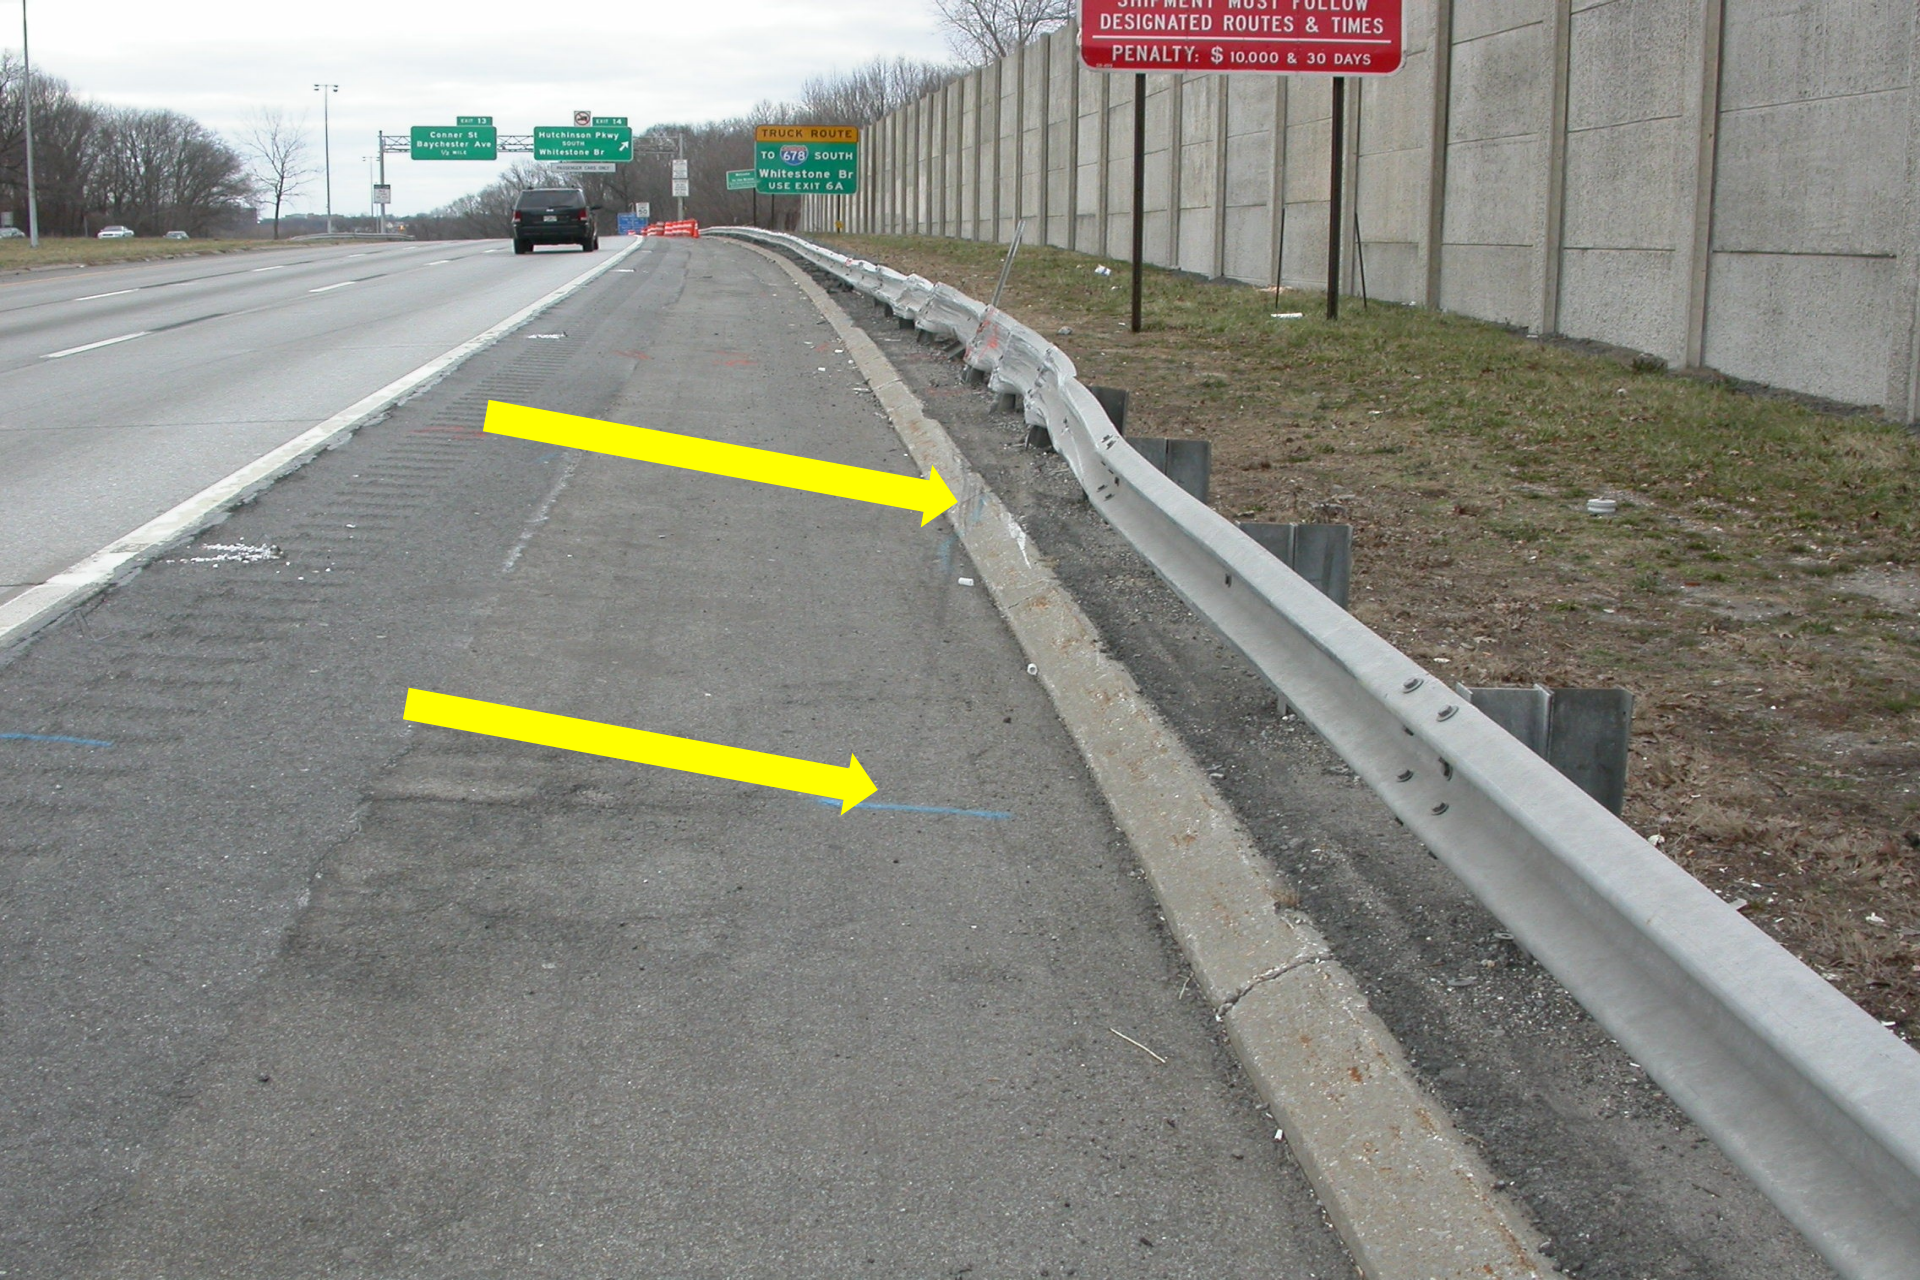
OTHER N.Y.C. LIMITS
HAZARDOUS LIQUEFIED
GAS TANK OR EXPLOSIVES
TRUCKS PROHIBITED
UNLESS AUTHORIZED BY NYC
FIRE DEPT. OR A TOWNSHIP
HAZARDOUS CARGO TANK
TRUCKS MUST FOLLOW
REGULATED ROUTES & TIMES
PENALTY: \$1,000 & 30 DAYS

TRUCK ROUTE
TO SOUTH
Whitestone Br
USE EXIT 6A

EXIT 13
Conner St
Baychester Ave
1/4 MI

EXIT 14
Whitman Pkwy
Whitestone Br
1/4 MI

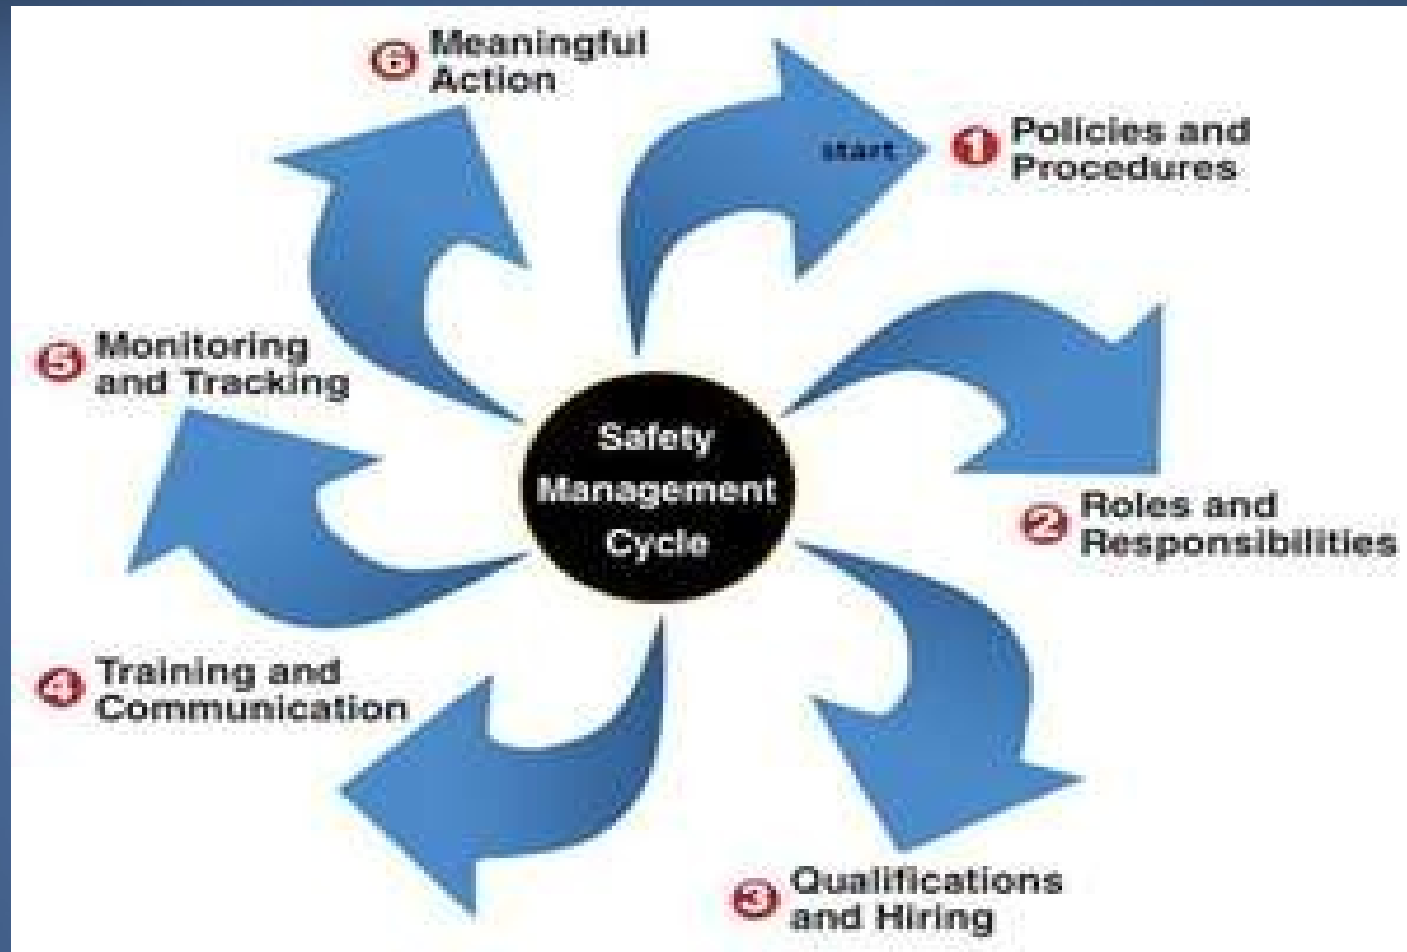
- FMCSAs – Safety Management Cycle
- 6 safety management processes
- Identify deficiencies in safety management controls

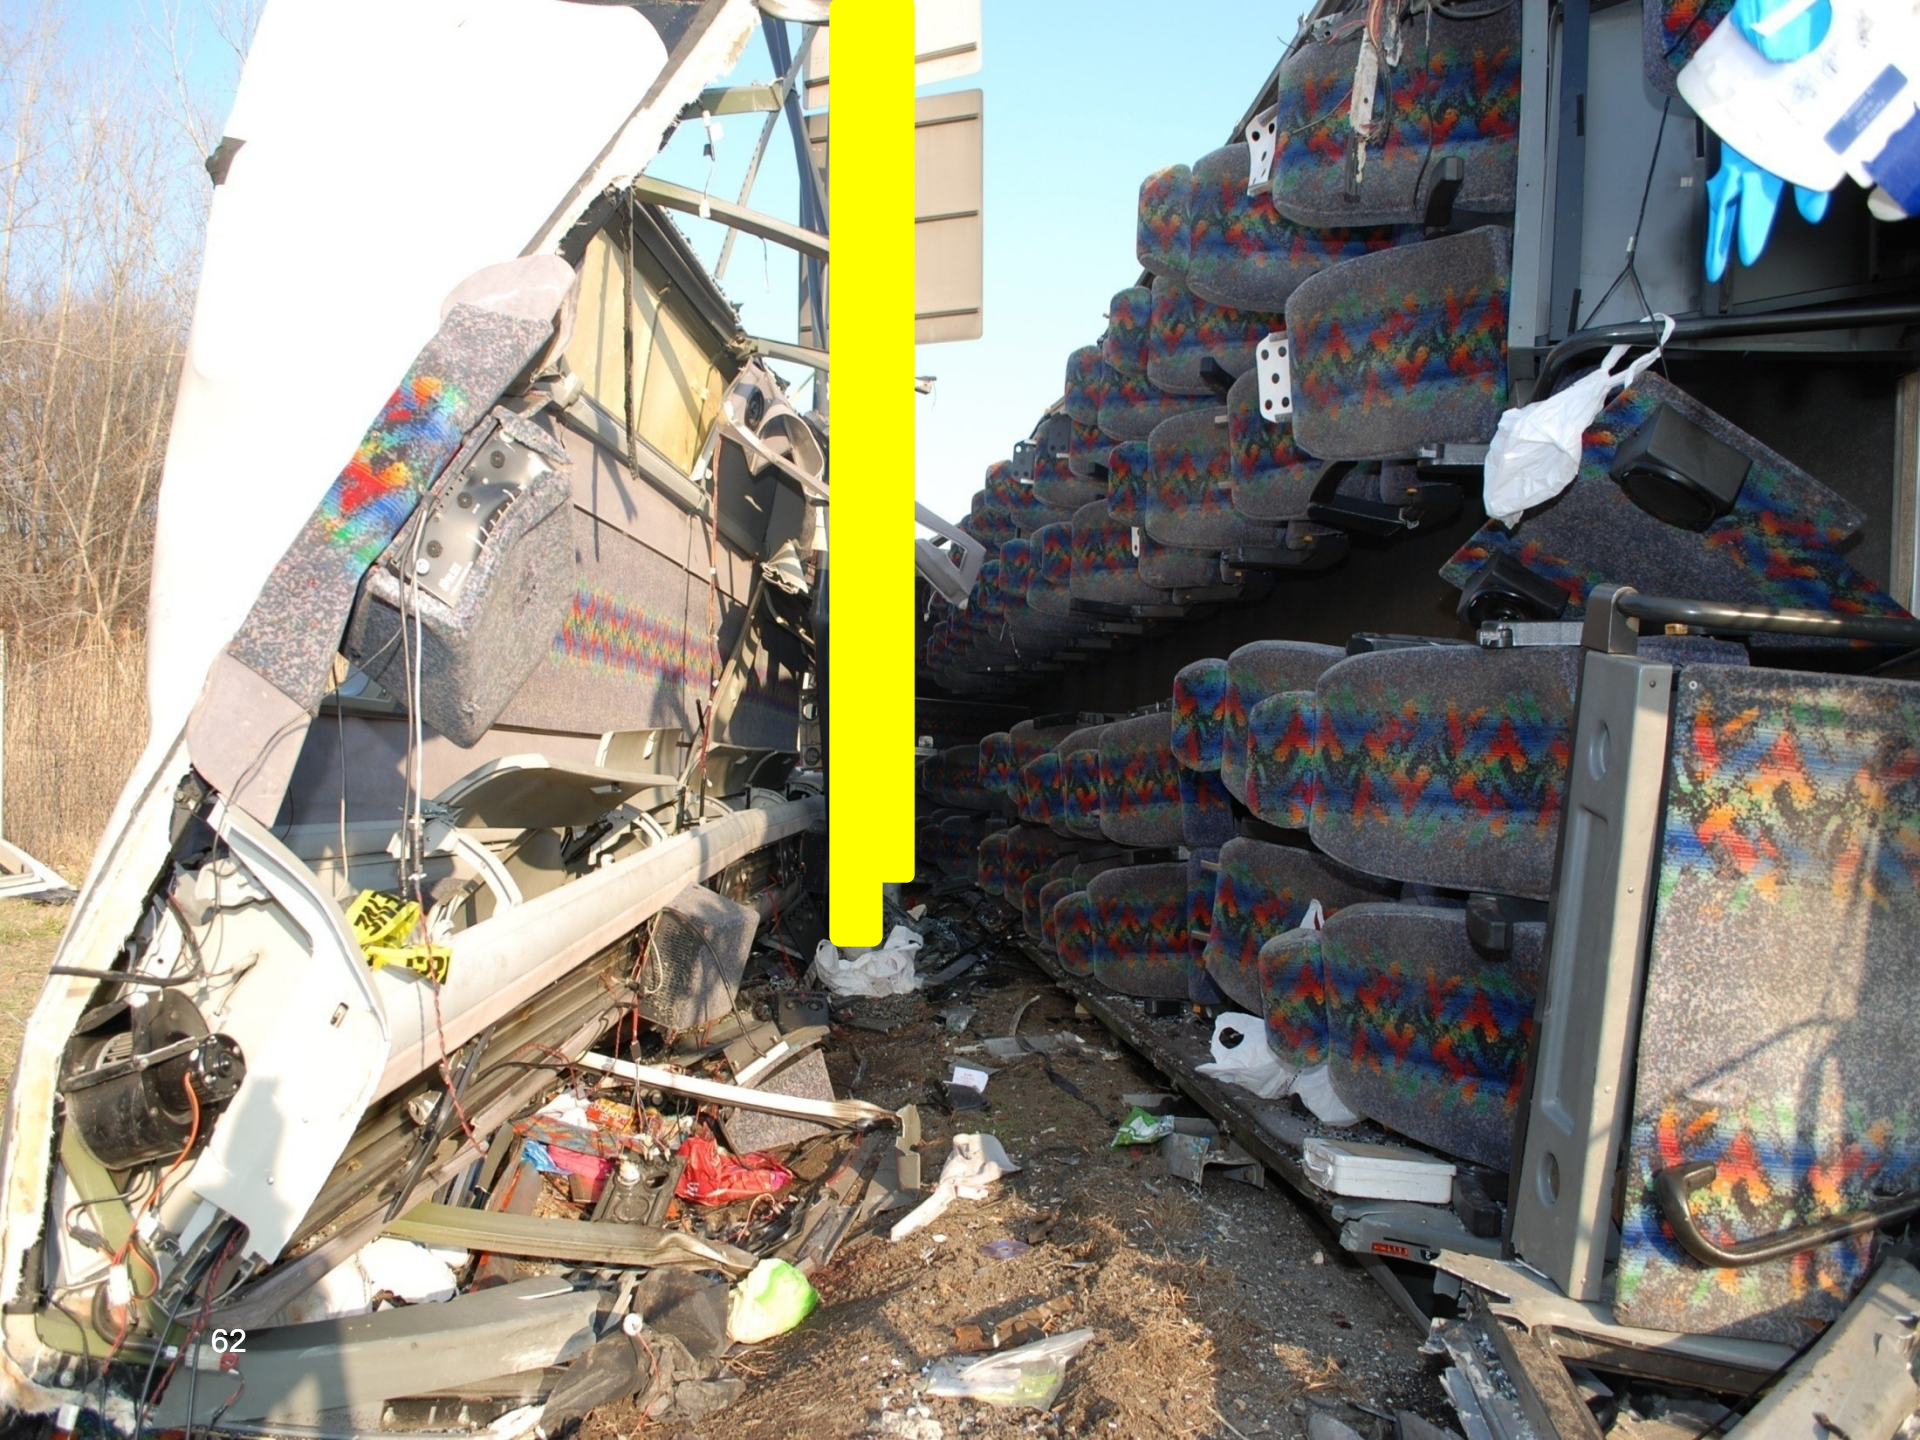
Injury Information

- Motorcoach occupants
 - 32 passengers (total capacity 56)
 - 15 fatalities
 - 7 serious injuries
 - 10 minor injuries
 - Driver – minor injuries
- Preaccident seat location for 9 occupants

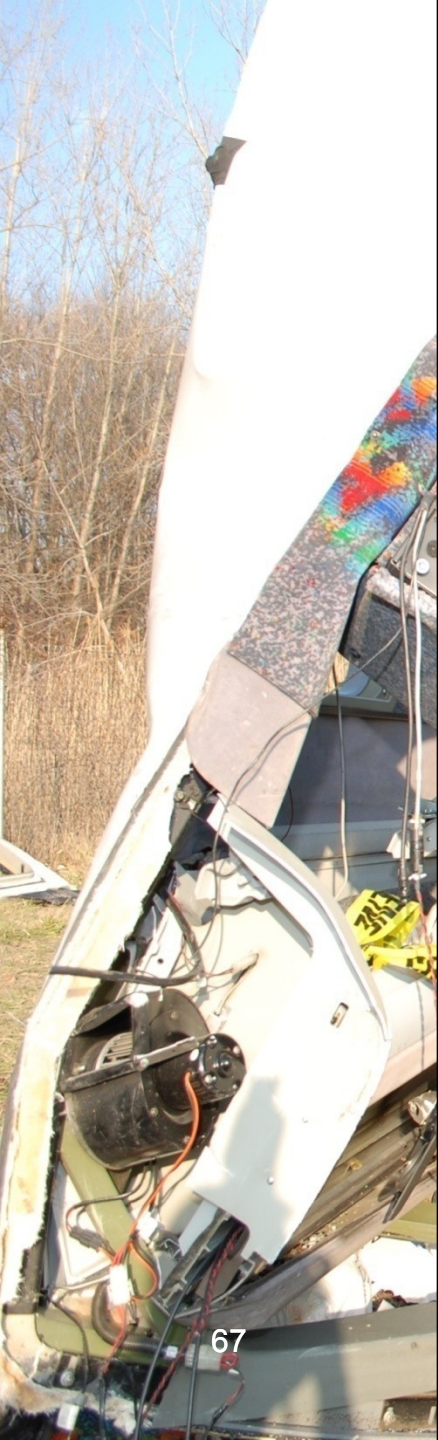
Results - Unrestrained

- Unrestrained passengers thrown from seats
- Vulnerable to
 - Injury during overturn
 - Intrusion from pole structure
 - Ejection

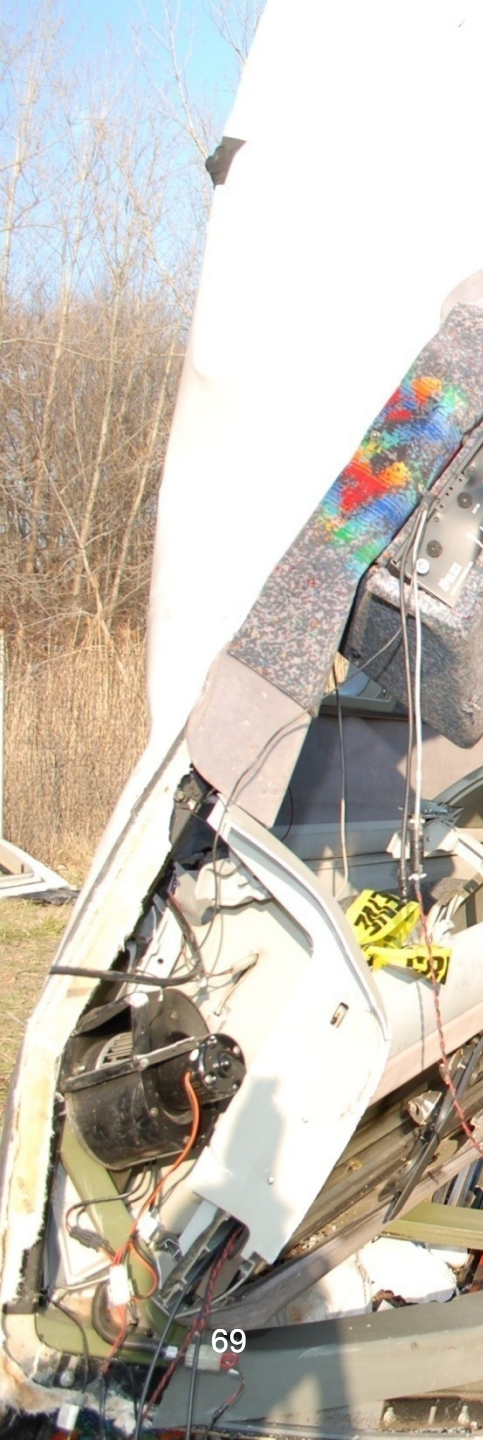
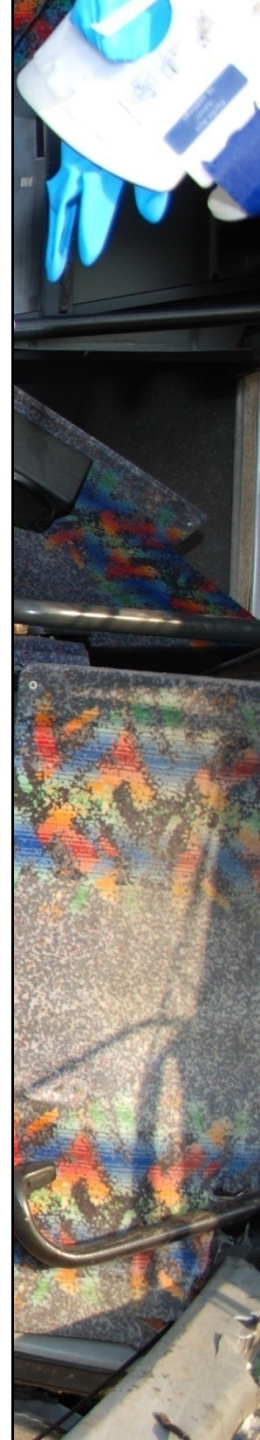
Results – Lap/Shoulder Belted

- Belted passengers contained within seats
 - Far-side occupants escaped shoulder harness
 - Low predicted injury levels
